Keeping

it cool

by Chris Walker

A cool roof case study investigates white roofs' energy efficiency

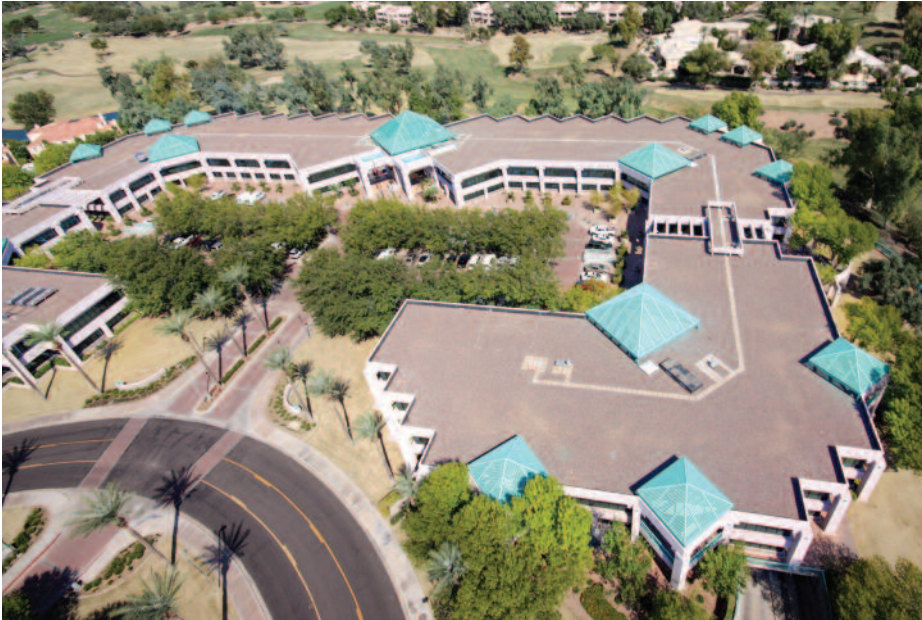
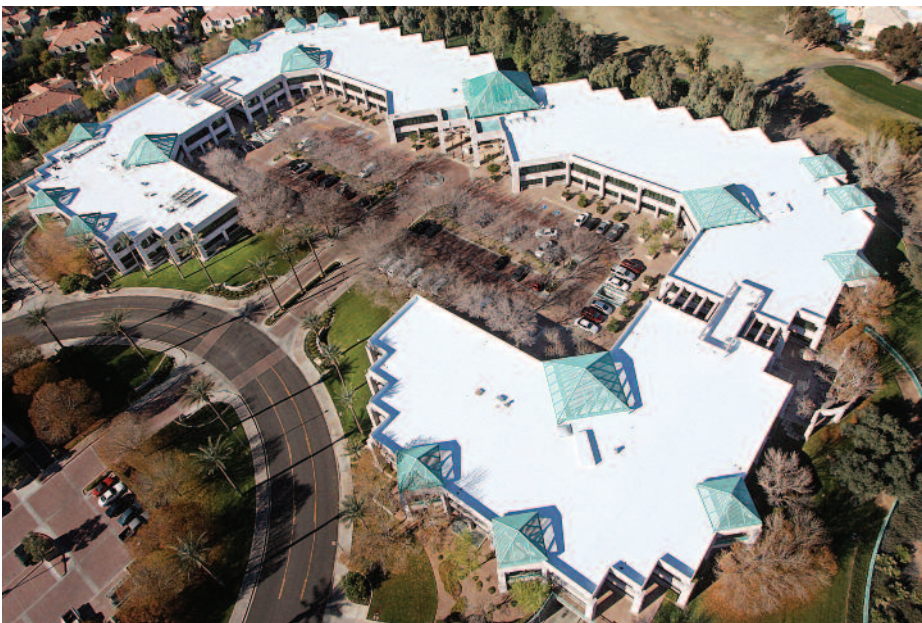
The Nationwide Scottsdale Insurance building before (top) and after (bottom) Starkweather Roofing installed the cool roof system

The building's original roof system was a ballasted EPDM membrane over 4 inches of polyisocyanurate insulation on a concrete roof deck blanketed with a 2-inch-thick layer of river rock. The roof system was becoming a liability with regard to structural integrity (from water damage), maintenance costs and energy consumption.

The new roof system was installed by Starkweather Roofing Inc., Phoenix, in December 2008 and consists of 3 inches of polyisocyanurate board insulation set in roof adhesive over the concrete roof deck and a self-adhering base sheet and self-adhering white laminated polymer-modified bitumen roof membrane over the top. The membrane's surface is a reflective white film laminate with a solar reflectance index (SRI) value of 84.

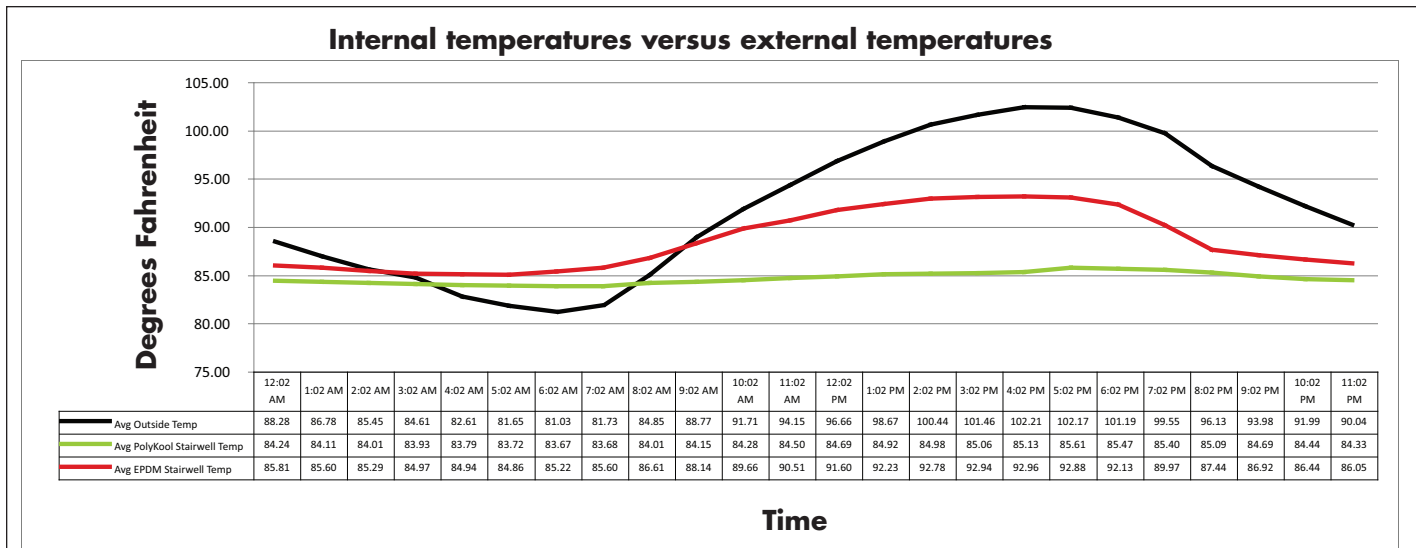
Figure 1: Average internal stairwell temperatures versus average external temperatures

In Figure 1, notice that between 10 p.m. and 6 a.m., the buildings have similar internal temperatures but the Wells Fargo Financial Services building always is hotter than the Nationwide Scottsdale Insurance building during the day. At 8 a.m., the Wells Fargo Financial Services building begins to heat up dramatically

Figure 1 also demonstrates how internal temperatures change as a result of outside temperatures. Notice how the Nationwide Scottsdale Insurance building's temperature holds steady all day while the Wells Fargo Financial Services building's temperature fluctuates rapidly. There is an

average range of only 2 degrees in internal temperature from the hottest to the coolest parts of the day inside the Nationwide Scottsdale Insurance building. Conversely, the Wells Fargo Financial Services building typically has an 8-degree range of internal temperature during a 24-hour period. For buildings as large as these two, a nearly 8-degree range means a lot in terms of the additional energy required to maintain a consistent temperature for the buildings' tenants.

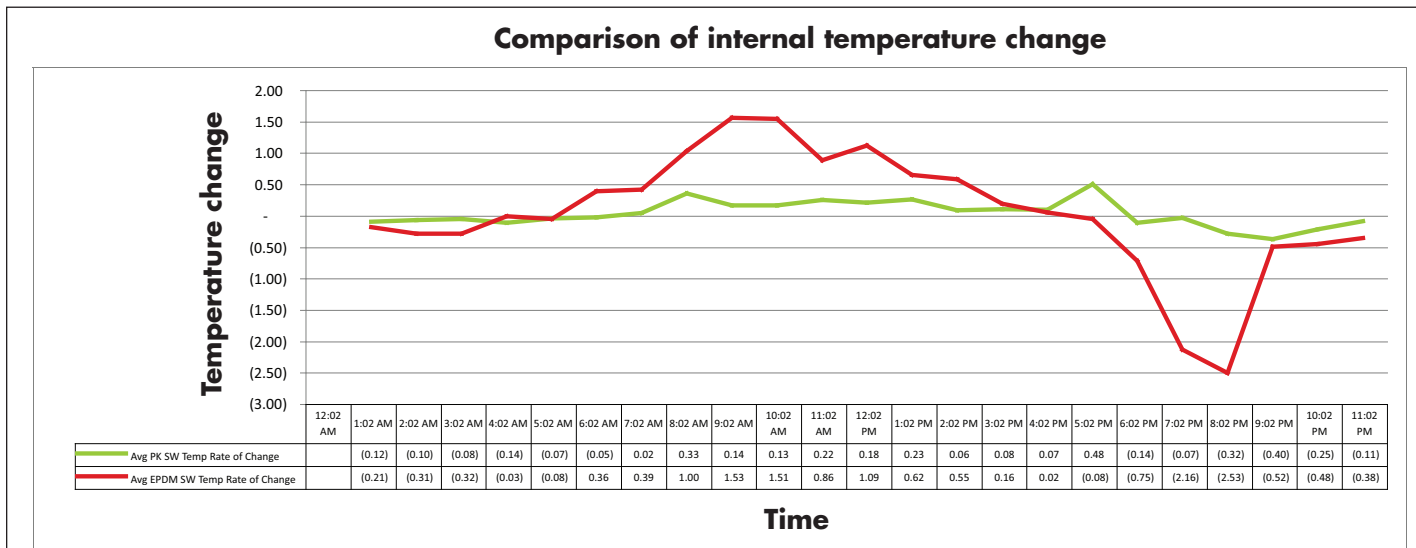
Figure 2: Average rates of change of internal stairwell temperature

while the Nationwide Scottsdale Insurance building remains virtually unchanged. Figure 2 shows between 5 p.m. and 8 p.m., the Wells Fargo Financial Services building cools down faster than it heated up and the Nationwide Scottsdale Insurance building's internal temperature again remains constant.

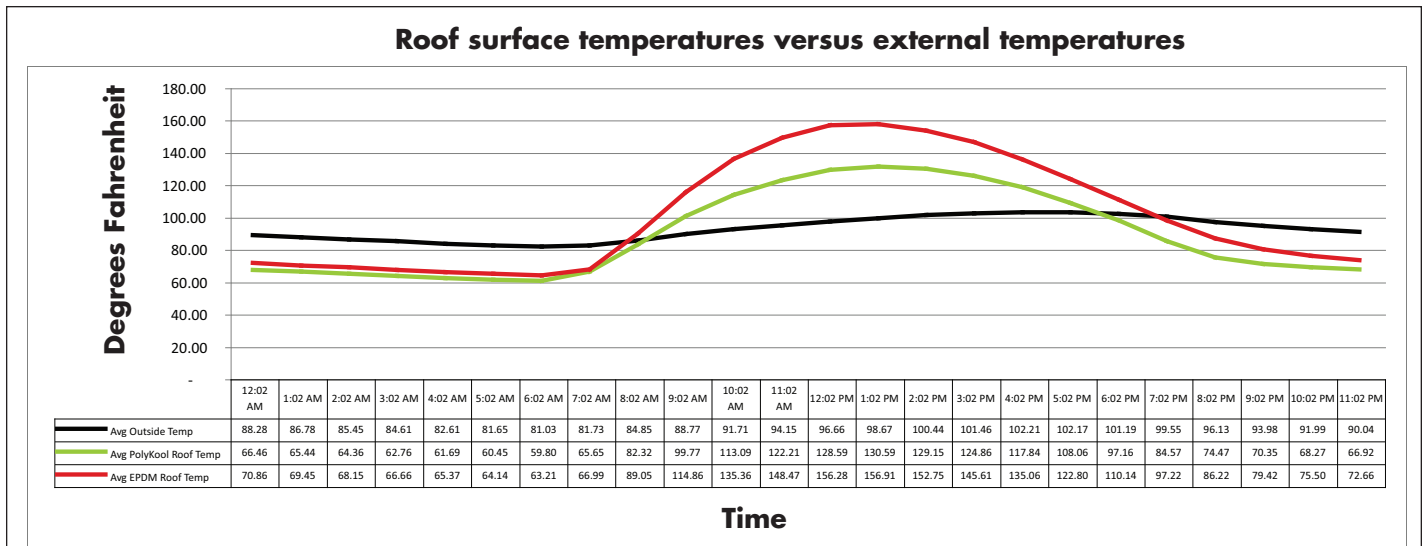
Figure 3: Average roof surface temperatures versus average external temperatures

Figure 3 shows that during the study, the largest difference in roof surface temperature occurred at noon when the average outside temperature was 97 F. The Wells Fargo Financial Services roof system on average was 156 F at that time, but the Nationwide Scottsdale Insurance roof system was only 129 F. That's a difference of 27 degrees. Between 9 a.m. and 5 p.m. (maximum sunlight hours), there is an average 22-degree difference in roof surface temperature, which is quite significant regarding the long-term survival of rooftop equipment (most rooftop equipment isn't constructed or warranted to last as long in such extreme temperatures), as well as the health of the building's facilities workers who have to perform work on the roof.
